Manhole Inspection Summary

Manhole # S03II2022MH

Insp Date: **7/7/06 10:27 AM**

Location Address: **2905 FALLSTAFF RD**

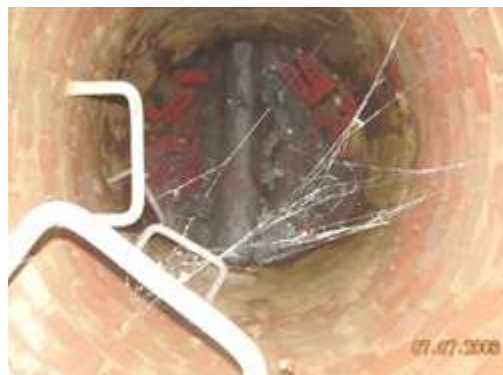
Top View

Bench debris.

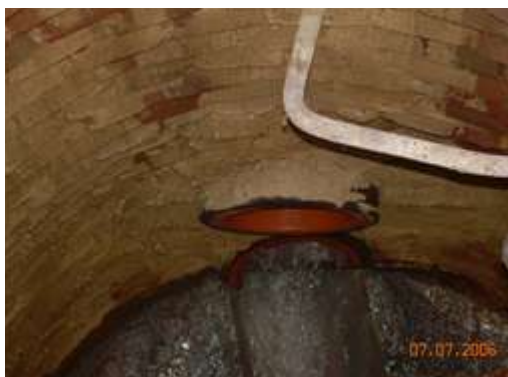
Close drop connection

Close drop connection.

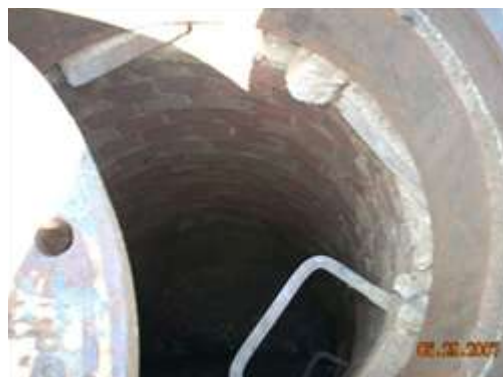
Defect

Frame leaks. Adjustment deterioration and loose brick. Adjustment, Corbel, and Barrel infiltration - other side.

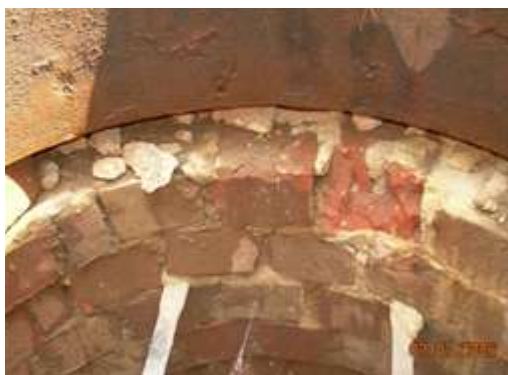
Defect

Frame leaks. Frame offset. Adjustment deterioration and loose brick. Adjustment infiltration.

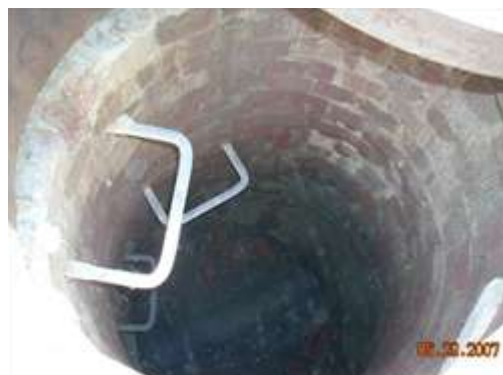
Defect

Frame leaks. Adjustment deterioration and loose brick. Adjustment, Corbel, and Barrel infiltration.

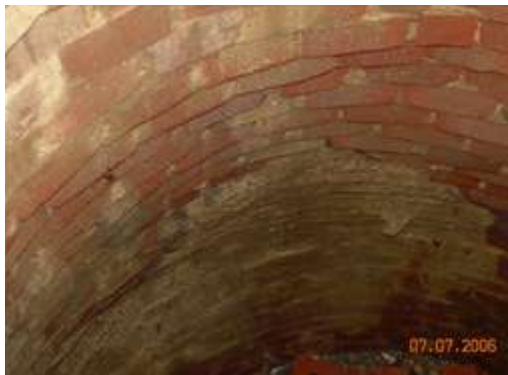
Defect

Corbel and Barrel infiltration.

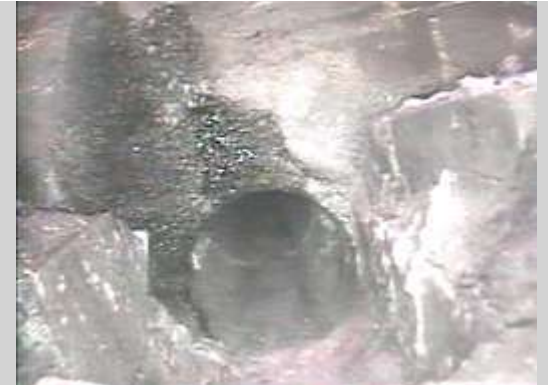
8 in. Circular Gravity Sewer Pipe Out @ 12 O'Clock

Infiltration: **Evidence** Pipe Seal Cond: **Unknown**

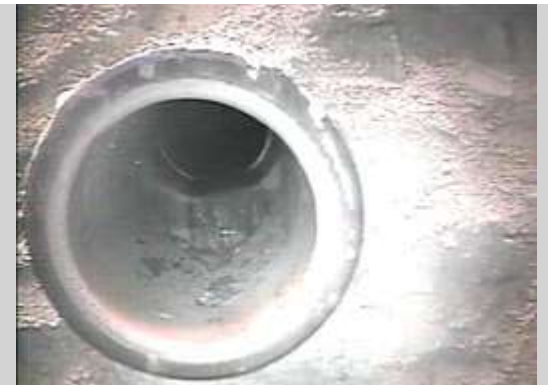
8 in. Circular Gravity Sewer Pipe In @ 6 O'Clock

Deposits: ☐ None ☐ Mud ☐ Sludge ☒ **Debris** ☐ Grease

Silt Depth: **1** (in.) Deposits Extent: **Light**

Infiltration: **Evidence** Pipe Seal Cond: **Unknown**
